CHICOPEE FALLS  
LOCAL PROTECTION PROJECT  
SPECIAL STUDY  
SLOPE PROTECTION IN PROJECT LIMITS

PREPARED FOR  
U. S. ARMY ENGINEER DIVISION  
NEW ENGLAND

OCTOBER, 1962

GREEN ENGINEERING AFFILIATES, INC.  
BOSTON MASSACHUSETTS

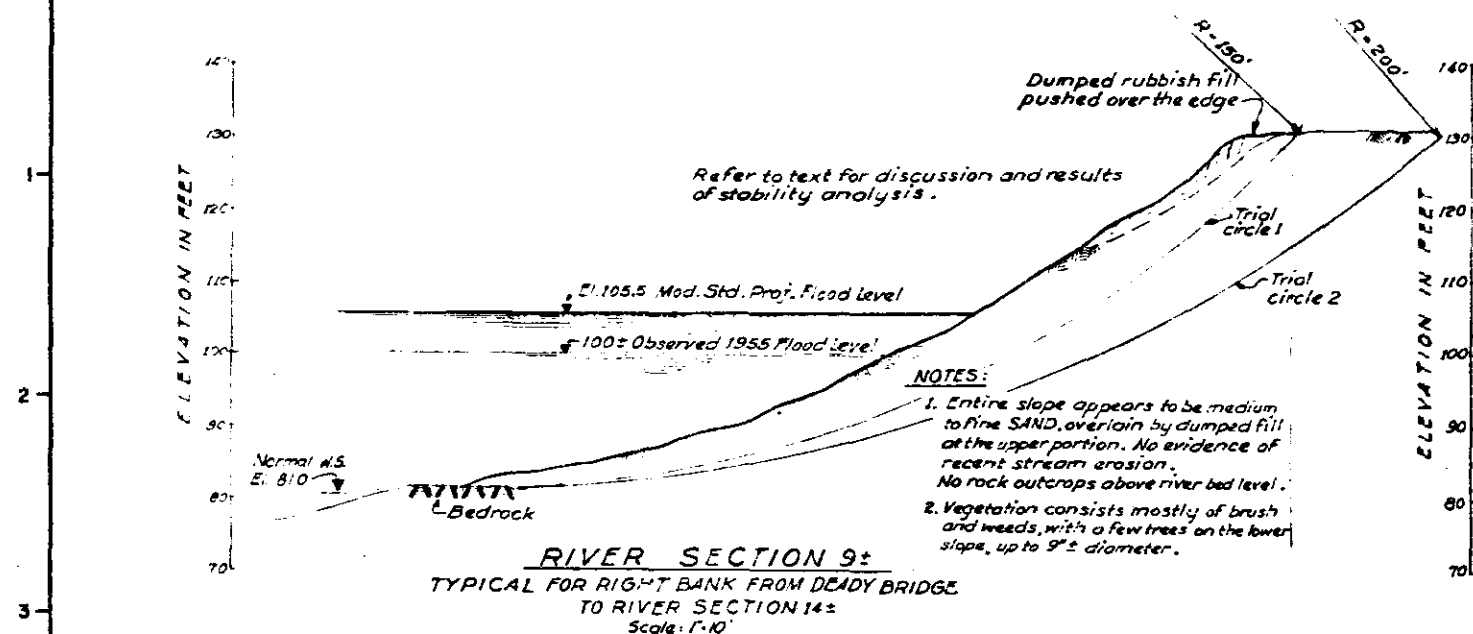
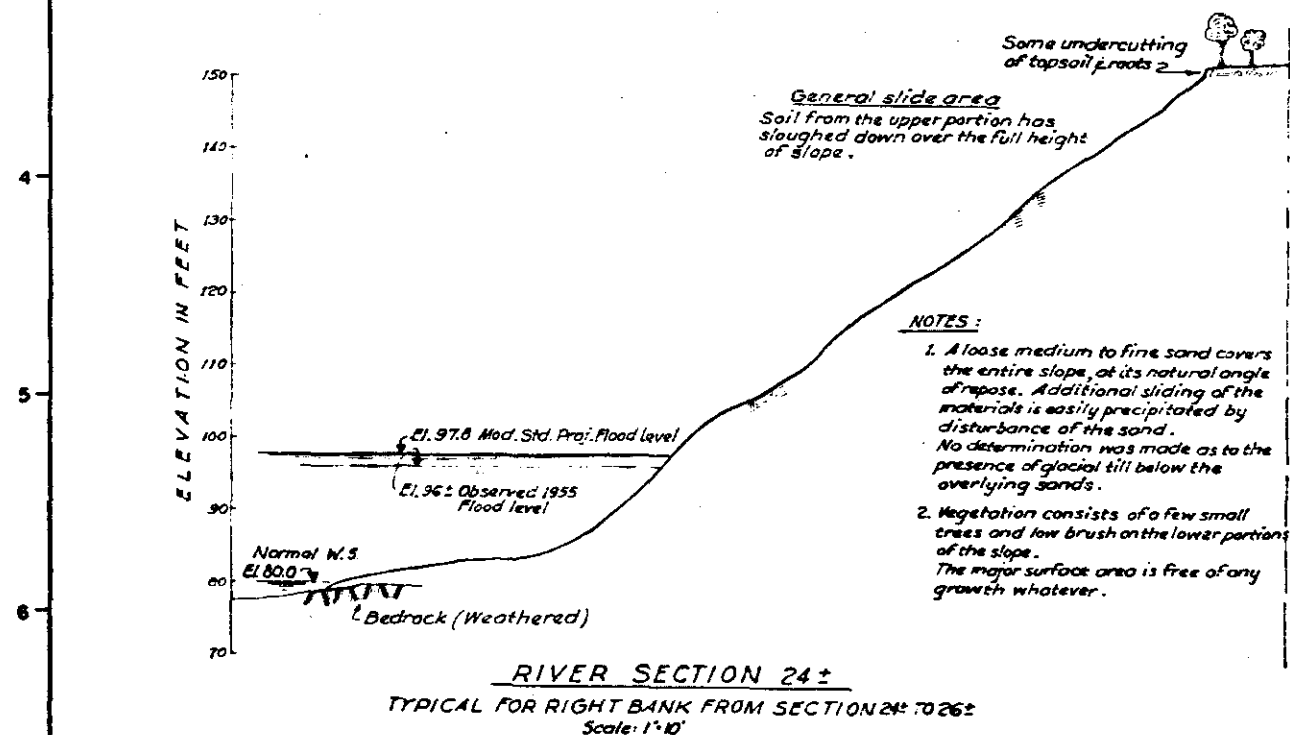
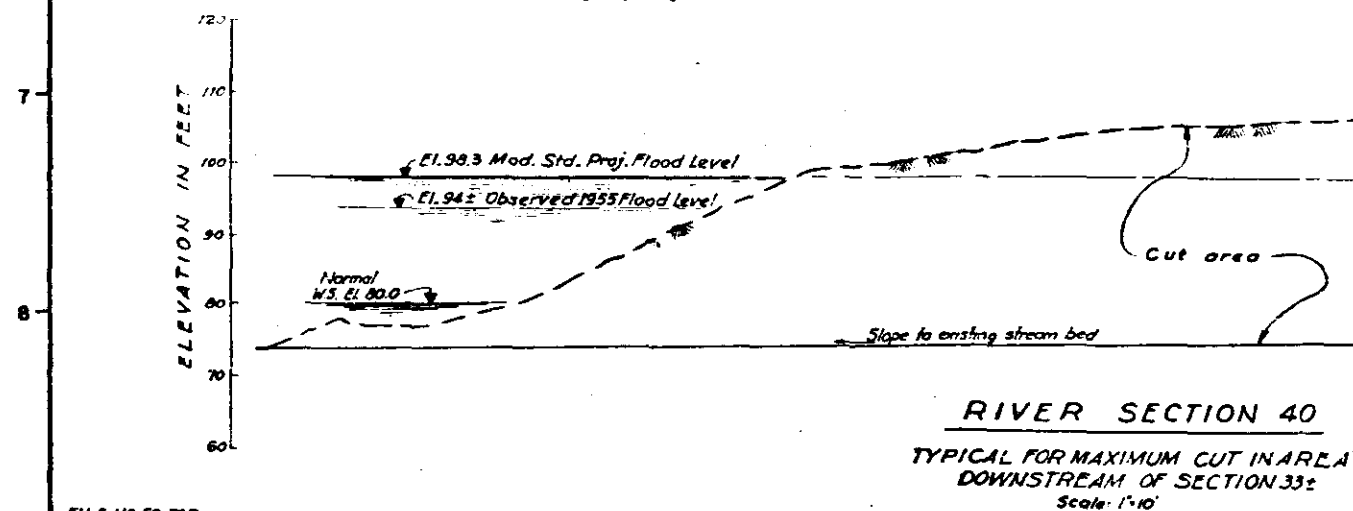
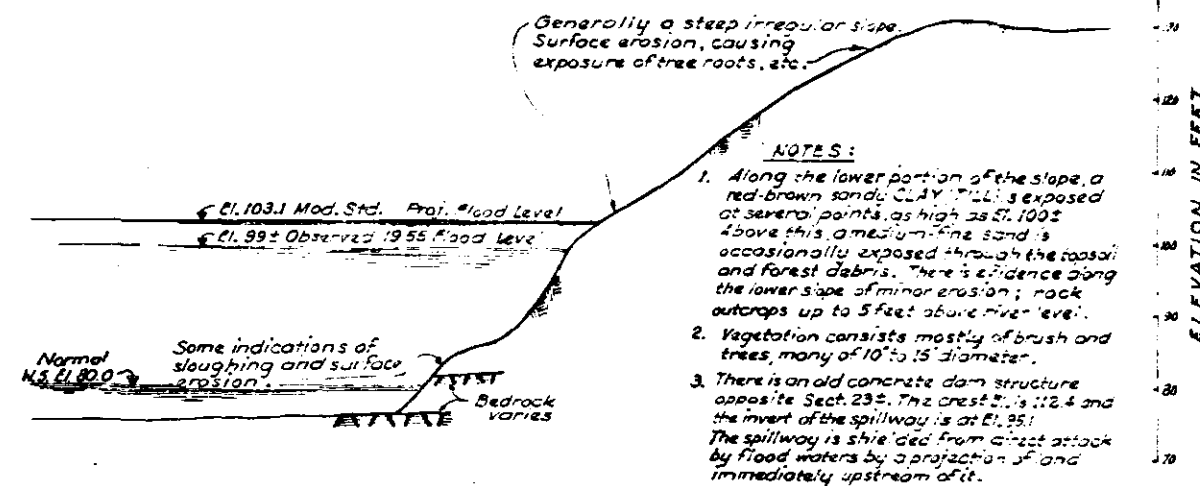
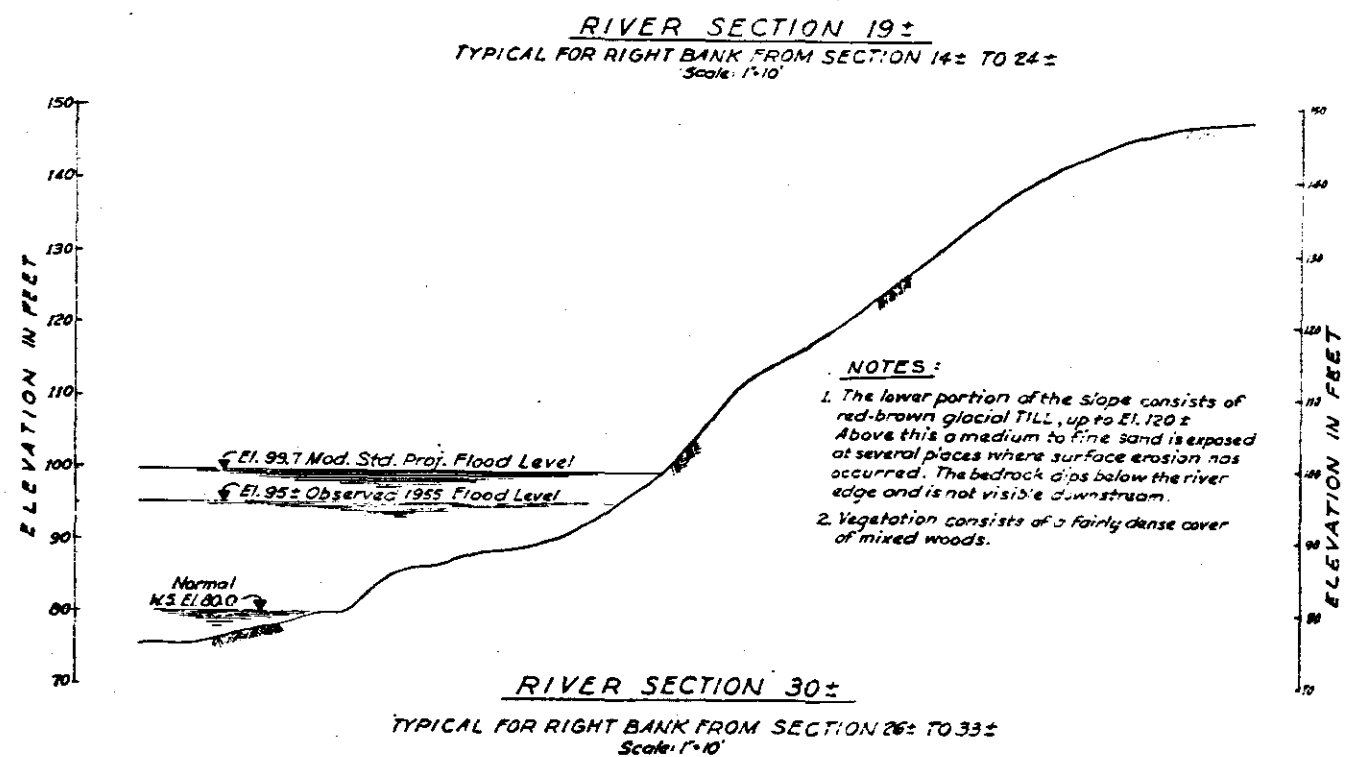
On Plate 3 are shown four typical cross-sections along the right bank which are considered to be representative of existing conditions, based on a reconnaissance of the entire area. The sections were selected at specific locations, with the appropriate design flood water elevations shown for those locations. There is usually a gradual transition in profile between the sections shown.

In general, the height of slope is from 50 to 75 feet above the river bottom, increasing in height in a downstream direction to approximately Section 30. The slope generally varies from 1 on 1.6 to 1 on 1.3 with a few somewhat steeper slopes near the river's edge, due apparently to river erosion. With the exception of the area in the vicinity of Section 24, the slopes are usually covered with a fairly dense growth of brush and trees. Specific comments are noted on each section in Plate 3.

To check on the stability of the existing slopes during flood stages, the right bank in the vicinity of Section 9 was selected for investigation. At this point, the design flood level extends nearly half way up the existing slope. It is assumed that soils of the entire slope are homogeneous and consist of medium to fine sand. Further downstream, the natural slopes are just as steep, and occasionally steeper,

The adopted soil data values were as follows: saturated unit weight, 125 pcf; moist unit weight, 110 pcf; angle of internal friction, 35 degrees; and no cohesion. The extreme case of "sudden drawdown" from the maximum flood stage to normal river level was investigated. This condition assumes that the water level drops so rapidly that drainage does not take place, so that the soil above the circular arc surface remains fully saturated, for purposes of determining the tangential driving forces. The forces normal to the arc are reduced by the hydrostatic pressures.

Two trial failure circles were assumed as indicated on Section 9, Plate 3. The computed Factor of Safety for Trial No. 1 is 1.10, and for Trial No. 2 is 1.36, both for the "sudden drawdown" case. In addition, the condition of a submerged slope under design flood level was analyzed for Circle No. 2. The computed factor of safety is 1.54. No further analyses are considered necessary.

The proposed cross-section is shown at Section 40, Plate 3. A berm, fifteen feet in width, will be maintained at Elevation 81. Below this berm a 1 on 2 slope is carried to the channel floor. A 1 on 2-1/2 slope extends upward the full height of slope above the berm. At this section, the total height of slope is approximately 30 feet above the berm. The berm provides access along the river edge for maintenance and also a shelf for retention of materials which might slide down from above. The berm is pitched toward the river to facilitate runoff.

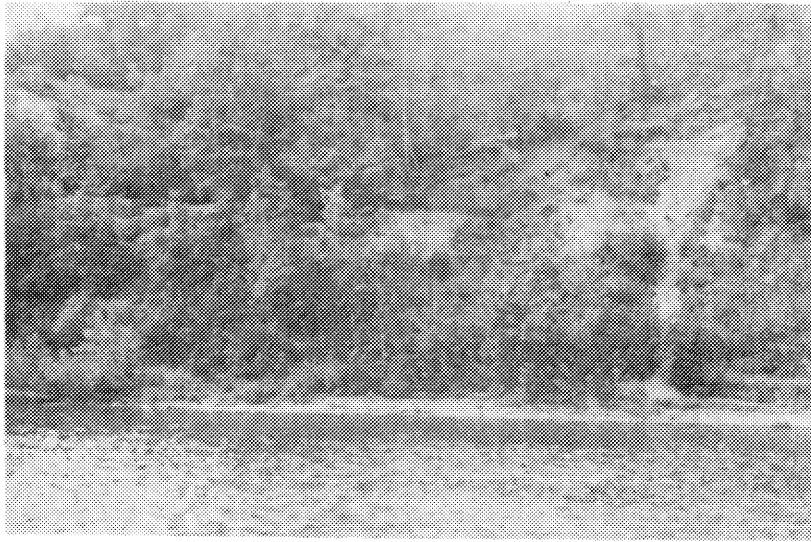
PHOTO #3

Taken from Mill #2 of Chicopee Mfg. Co.

(Section #22)

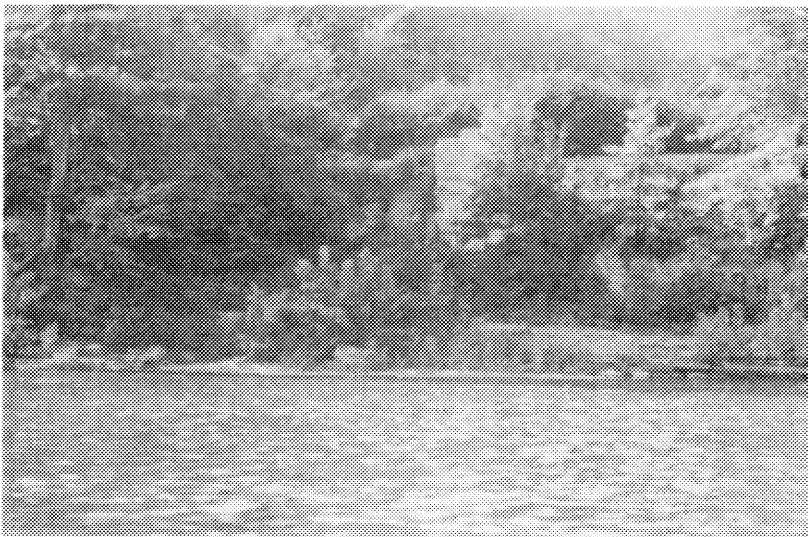
PHOTO #4

At Section 24 <sup>±</sup>, there is a steep slope where, for a distance of some 240 feet along the river, the medium to fine sand stands at its natural angle of repose indicating that sloughing has occurred and is still continuing at a slow rate. Sand from the upper portion, some 70 feet above river

level, has sloughed down over the entire slope, with some buildup of materials at the toe of slope. As a result, very little vegetation has taken root in this area. The average angle of the slope is approximately 35 degrees above the horizontal. The material is a light brown medium to fine sand.

As for the open area near Section 24, it is expected that surficial sliding of the sand will continue as a result

of wind erosion, surface runoff, freezing, thawing, etc. The slope should not become much steeper inasmuch as the sand has reached its normal angle of repose. Some losses of material can be expected along the toe of slope due to erosive action of the river during flood conditions, together with possible minor losses due to rapid drawdown. Again, there is no known overall stability problem which would result in any major blockage to the river. Minor losses at the toe due to materials carried downstream would be quickly replaced by material sliding down the surface from above.

Taken from a point 300' downstream from  
Mill #2 of Chicopee Mfg. Co.

(Section #24)

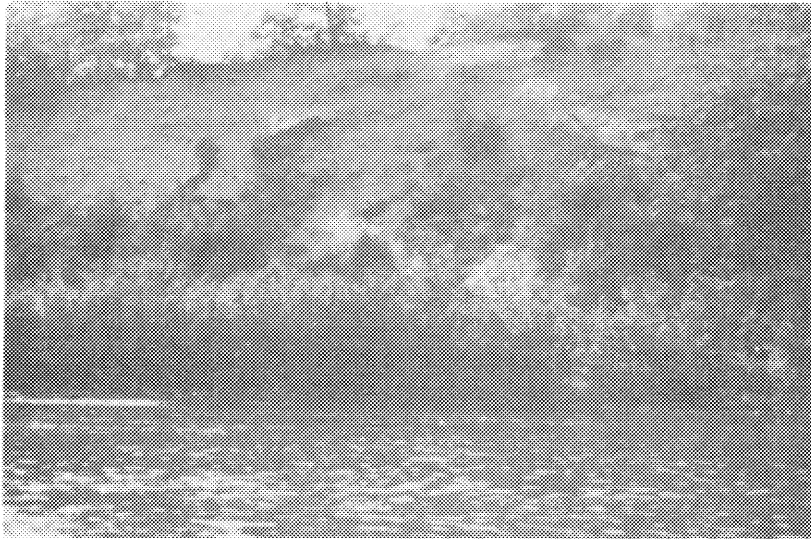
PHOTO #5

Taken from a point 400' downstream from  
Mill #2 of Chicopee Mfg. Co.

(Section #25)

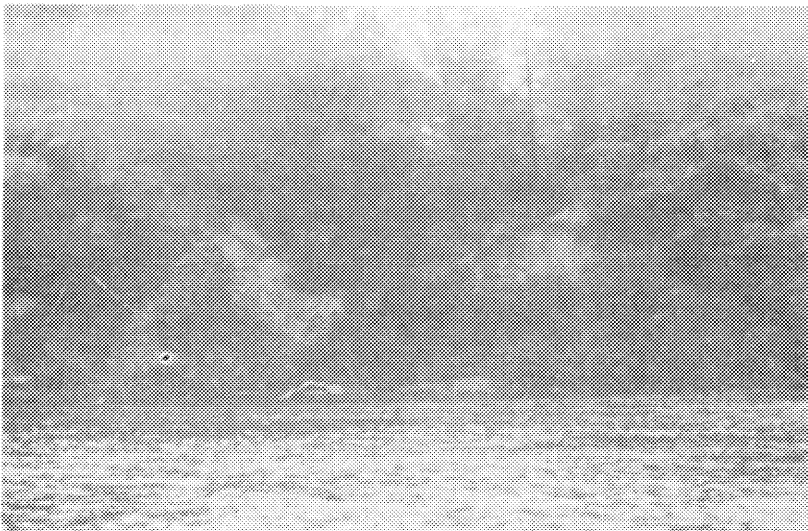
PHOTO #6

Taken from a point 400' downstream from  
Mill #2 of Chicopee Mfg. Co.

(Section #25)

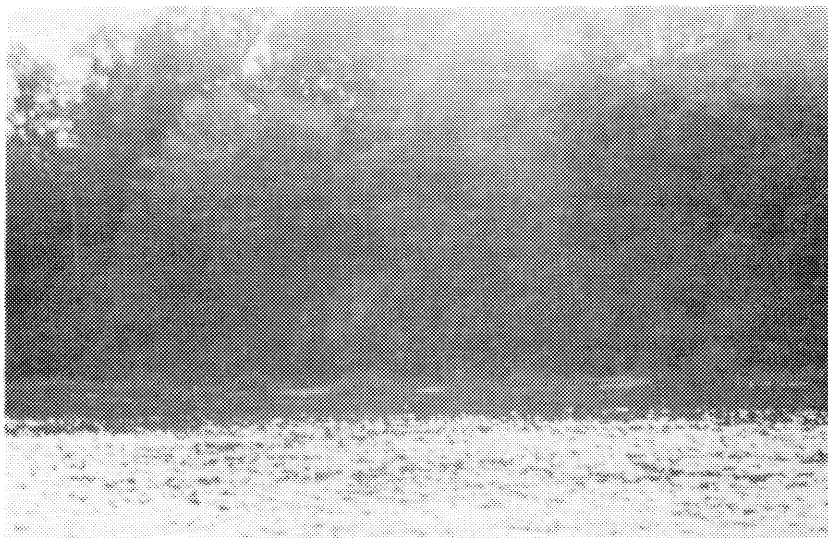
PHOTO #7

Taken from a point 400' downstream from  
Mill #2 of Chicopee Mfg. Co.,  
(Section #25)

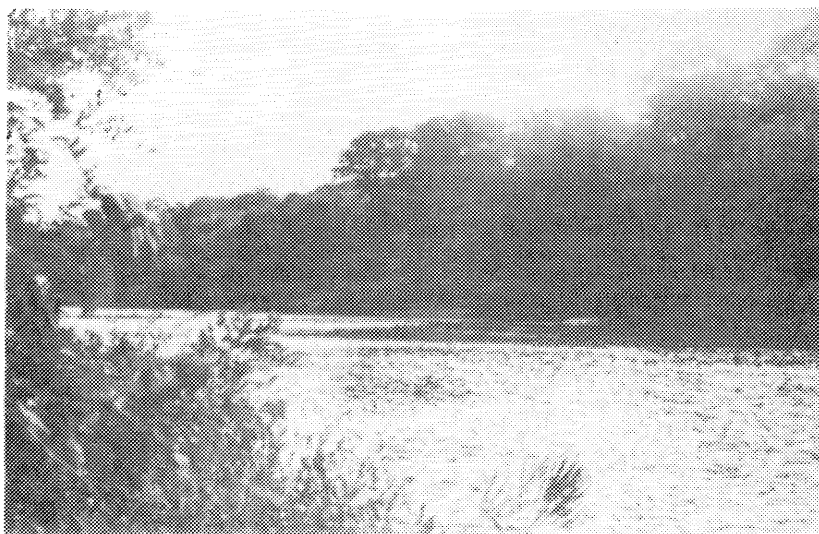
PHOTO #8

Taken from a point 400' downstream from  
Mill #2 of Chicopee Mfg. Co.  
(Section #25)
